X International Conference on Structural Dynamics, EURODYN 2017

Dynamic evaluation of a historic fountain under blast loading

F. Javier Baeza^a, Salvador Ivorra^{a*}, David Bru^a, F. Borja Varona^a^a*Civil Engineering Department, University of Alicante. Aptd. 99, Alicante 03080, Spain*

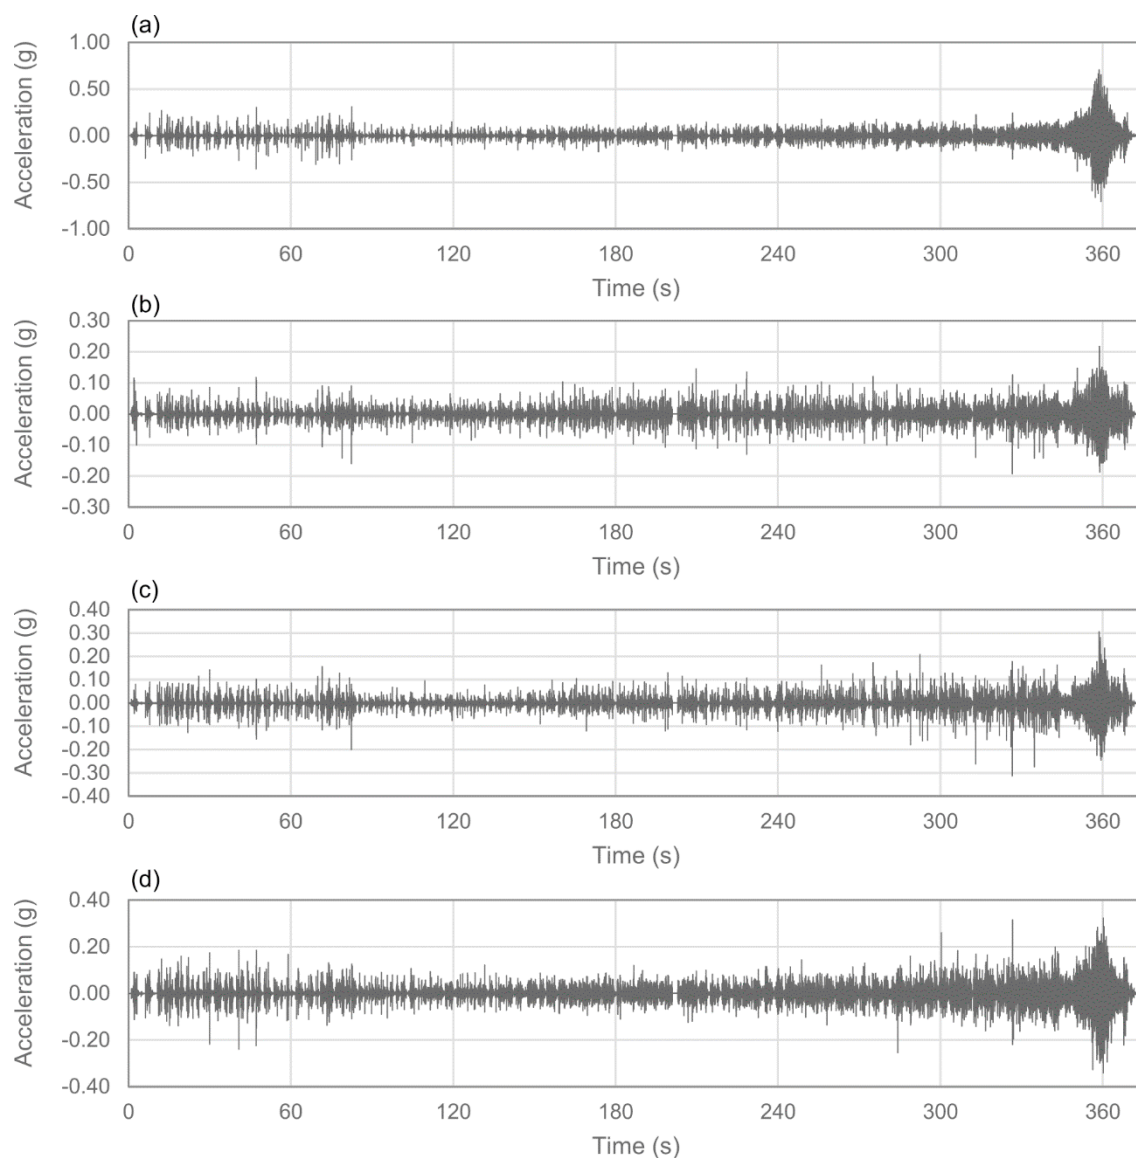
Figure 4 includes four time-functions for accelerations at different sensors during all the fireworks show. Initially the explosives are detonated at different frequencies. In the middle part the intensity of almost all accelerations was lower, and during the final part (which name can be translated as earthquake) there was an amplification of the dynamic response, and maximum accelerations were registered at all sensors. The corresponding peak accelerations for each accelerometer have been included in Table 2.

Fig. 4. Accelerations registered at different sensors: (a) A8; (b) A5; (c) A6; (d) A1.

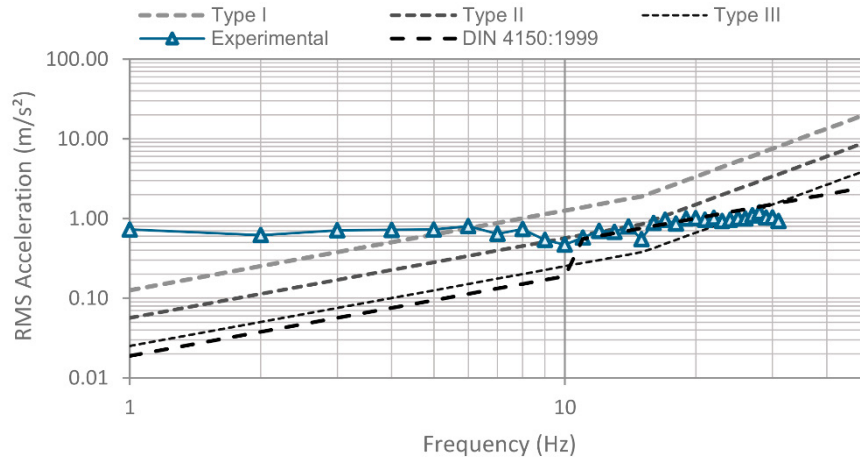
Afterwards, each signal was analyzed in the frequency domain, and RMS accelerations were assessed for each frequency. Thus, in Figure 5, RMS acceleration for the triaxial device (A5-A6-A7) is shown, and compared to limit values included in different European standards, i.e. UNE 22381:1993 [4] and DIN 4150 [10]. Due to the characteristics of the fountain a Type III structures can be assumed according to [4]. This limit is similar to the curve for the German standard [10]. For the analyzed frequencies, between 1 and 20 Hz, there level of ground vibrations

was too high for frequencies below 20 Hz according to Spanish standard. Similar results were observed for all sensors, hence additional measures should be taken in order to avoid further damage to the monument. Furthermore, a detailed numerical analysis should be made in order to assess the influence of the concrete slab of the station on the vibrations. Despite there aren't any data prior to the construction of the underground station, the location of the blast area, directly on the slab could increase the wave's transmission velocity. Therefore two measures should be considered, first a relocation of the point of blast, so it doesn't interfere with the station's structure. And second, if this option is not possible, a platform can be cast between the charges and the pavement, hence additional dampers can be used to control vibrations related to these low frequencies, which showed values above guidelines and standards.

Fig. 5. RMS acceleration for each excited frequency at ground level (dashed lines correspond to different standard limits for damage control)
